Scottish Single Survey

Property address	23 Gleneagles Road Kilmarnock KA1 2PT
------------------	---

Prepared by	Shepherd Chartered Surveyors
-------------	------------------------------

Date of inspection	19/09/2024

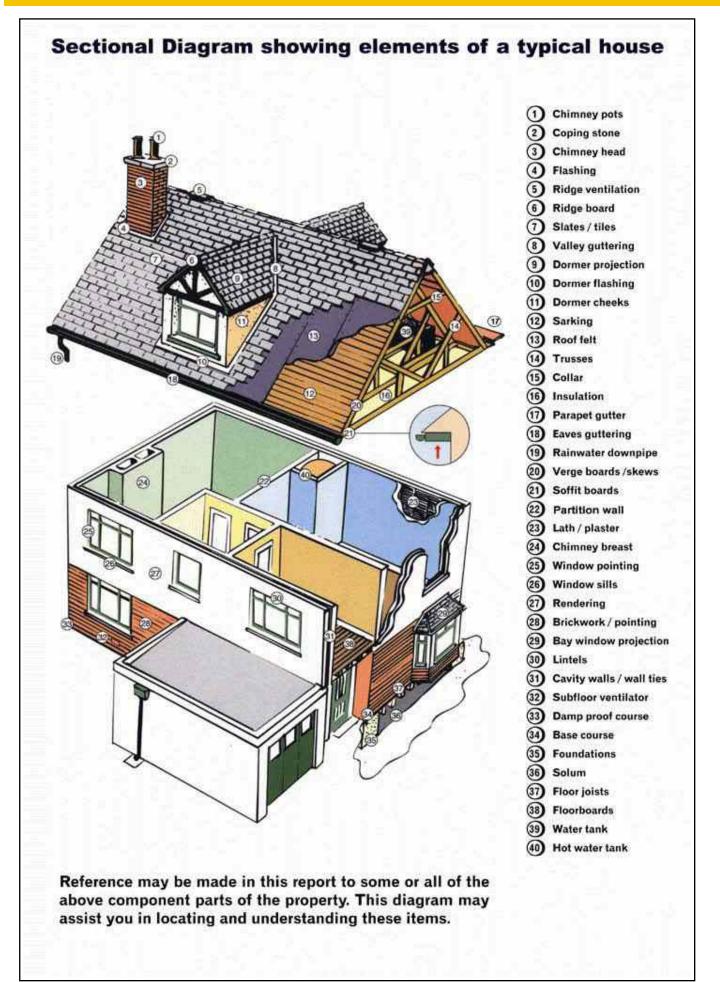
Description	The subjects comprise a detached house.	
Accommodation	Ground Floor: Entrance Hall, Living Room with Dining Area, Kitchen and Cloakroom with WC.First Floor: Landing, Master Bedroom with En Suite Shower Room, Two further Bedrooms and Bathroom with WC.	
Gross internal floor area (m ²)	The gross internal floor area extends to 102 sq m or thereby.	
Neighbourhood and location	The subjects are located within a well established residential estate of similar style private dwellings within the Fardalehill development in Kilmarnock. Local amenities can be found within a reasonable distance.	
Age	Constructed around 2020.
