# Home Report

# Scottish Single Survey

survey report on:

<b>Property address</b>	13 Glebe Avenue Kilmarnock KA1 3DX
<b>Customer</b>	Gerald Ferguson
<b>Customer address</b>	13 Glebe Avenue Kilmarnock KA1 3DX
<b>Prepared by</b>	Shepherd Chartered Surveyors
<b>Date of inspection</b>	02/08/2024

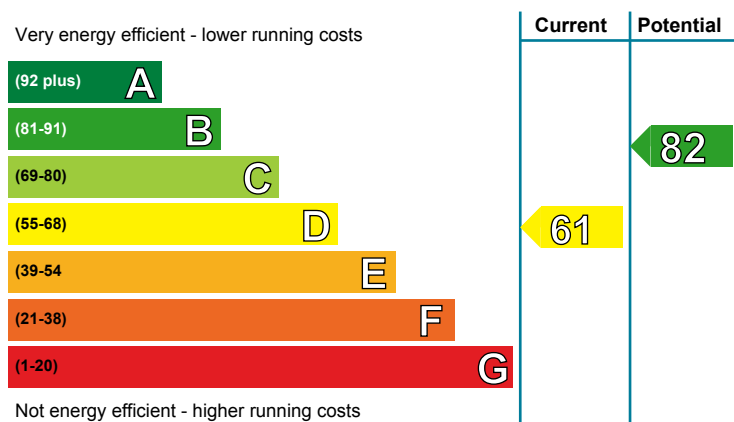
## Energy Efficiency Rating

This graph shows the current efficiency of your home, taking into account both energy efficiency and fuel costs. The higher this rating, the lower your fuel bills are likely to be.

Your current rating is **band D (61)**. The average rating for EPCs in Scotland is **band D (61)**.

The potential rating shows the effect of undertaking all of the improvement measures listed within your recommendations report.

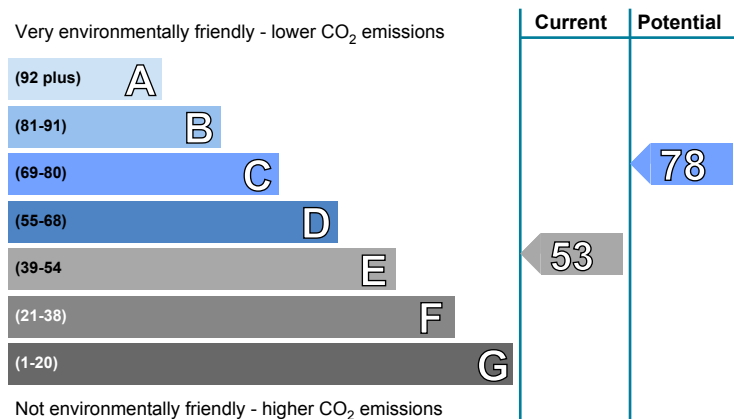
## Environmental Impact (CO<sub>2</sub>) Rating

This graph shows the effect of your home on the environment in terms of carbon dioxide (CO<sub>2</sub>) emissions. The higher the rating, the less impact it has on the environment.
