# HOME REPORT

16 CROCUS GROVE  
IRVINE  
KA12 0XW

# Energy Performance Certificate (EPC)

16 CROCUS GROVE, IRVINE, KA12 0XW

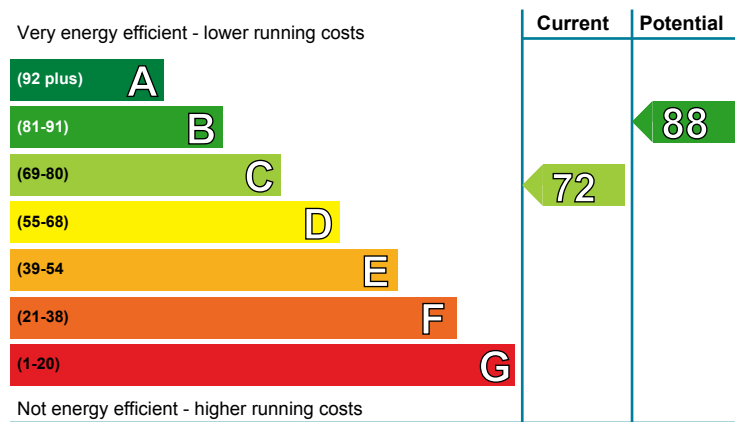
## Energy Efficiency Rating

This graph shows the current efficiency of your home, taking into account both energy efficiency and fuel costs. The higher this rating, the lower your fuel bills are likely to be.

Your current rating is **band C (72)**. The average rating for EPCs in Scotland is **band D (61)**.

The potential rating shows the effect of undertaking all of the improvement measures listed within your recommendations report.

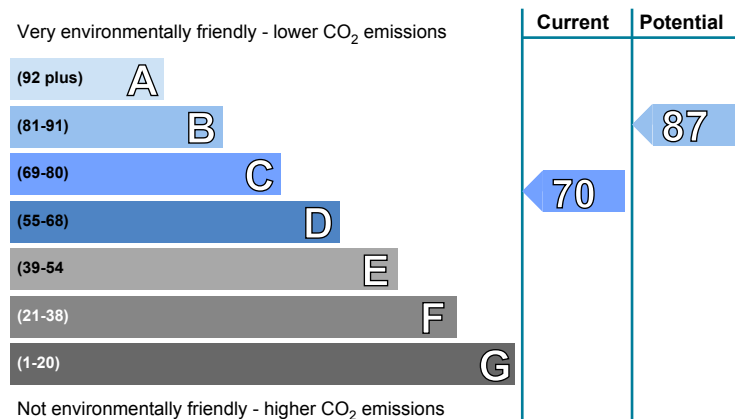
## Environmental Impact (CO<sub>2</sub>) Rating

This graph shows the effect of your home on the environment in terms of carbon dioxide (CO<sub>2</sub>) emissions. The higher the rating, the less impact it has on the environment.

Your current rating is **band C (70)**. The average rating for EPCs in Scotland is **band D (59)**.

The potential rating shows the effect of undertaking all of the improvement measures listed within your recommendations report.

The average Scottish household produces about 6 tonnes of carbon dioxide every year. Based on this assessment, heating and lighting this home currently produces approximately 2.8 tonnes of carbon dioxide every year. Adopting recommendations in this report can reduce emissions and protect the environment. If you were to install all of these recommendations this could reduce emissions by 1.6 tonnes per year. You could reduce emissions even more by switching to renewable energy sources.
