# Home Report

# Single Survey

<b>Property address</b>	26 Main Road Fenwick Kilmarnock KA3 6AH
<b>Customer</b>	Anthony Bone
<b>Customer address</b>	26 Main Road Fenwick Kilmarnock KA3 6AH
<b>Prepared by</b>	Shepherd Chartered Surveyors
<b>Date of inspection</b>	26/02/2024

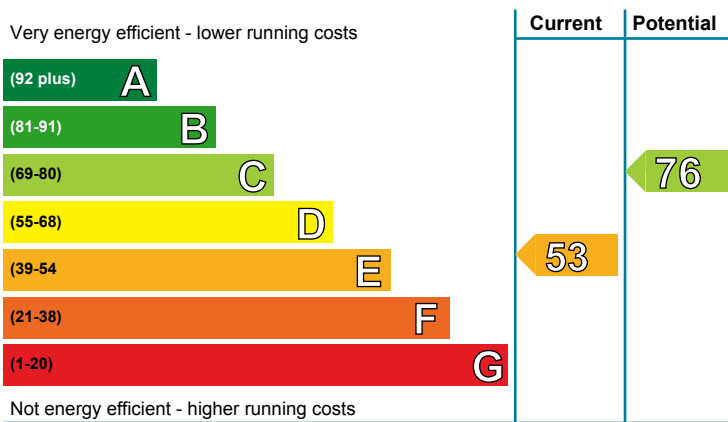
## Energy Efficiency Rating

This graph shows the current efficiency of your home, taking into account both energy efficiency and fuel costs. The higher this rating, the lower your fuel bills are likely to be.

Your current rating is **band E (53)**. The average rating for EPCs in Scotland is **band D (61)**.

The potential rating shows the effect of undertaking all of the improvement measures listed within your recommendations report.

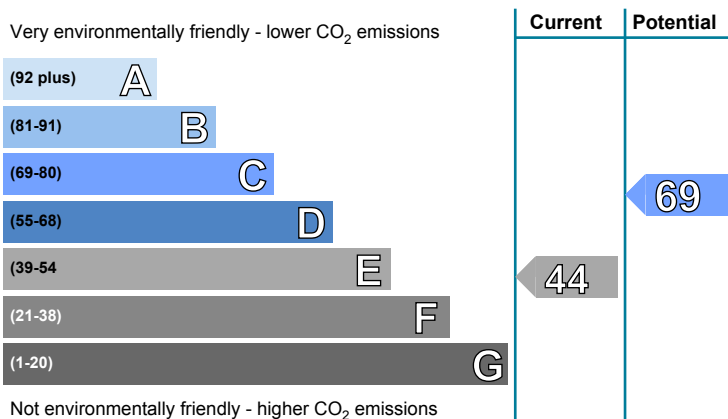
## Environmental Impact (CO<sub>2</sub>) Rating

This graph shows the effect of your home on the environment in terms of carbon dioxide (CO<sub>2</sub>) emissions. The higher the rating, the less impact it has on the environment.
