Home Report

Single Survey

Property address	3 Welton Road Mauchline KA5 6AG
-------------------------	---------------------------------------

Prepared by	Shepherd Chartered Surveyors
--------------------	------------------------------

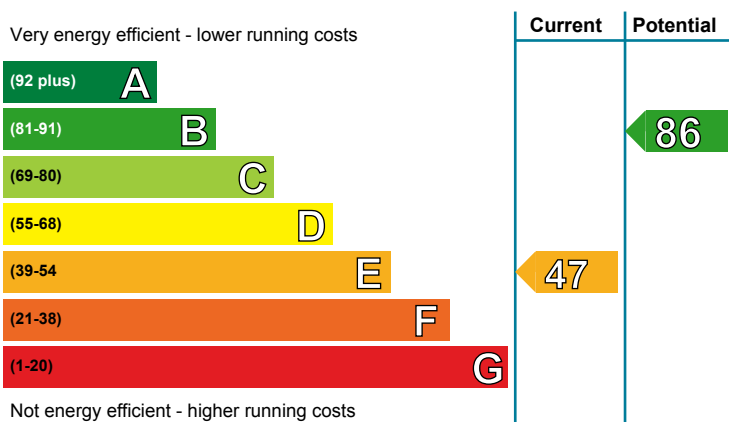
Energy Efficiency Rating

This graph shows the current efficiency of your home, taking into account both energy efficiency and fuel costs. The higher this rating, the lower your fuel bills are likely to be.

Your current rating is **band E (47)**. The average rating for EPCs in Scotland is **band D (61)**.

The potential rating shows the effect of undertaking all of the improvement measures listed within your recommendations report.

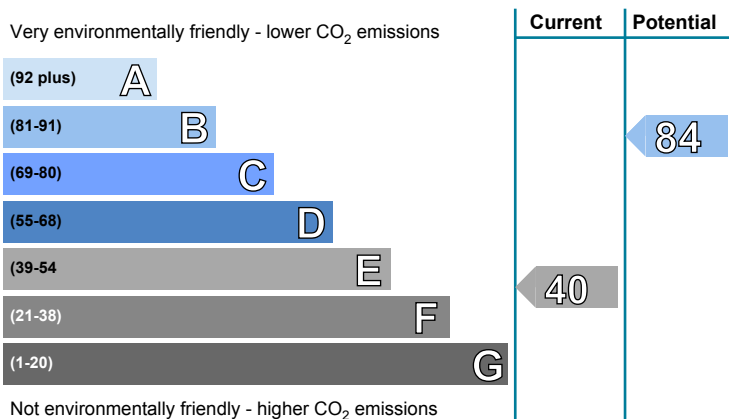
Environmental Impact (CO₂) Rating

This graph shows the effect of your home on the environment in terms of carbon dioxide (CO₂) emissions. The higher the rating, the less impact it has on the environment.
