Home Report

Scottish Single Survey

Property address	4 Winton Avenue KILWINNING KA13 6LH
-------------------------	---

Prepared by	Shepherd Chartered Surveyors
--------------------	------------------------------

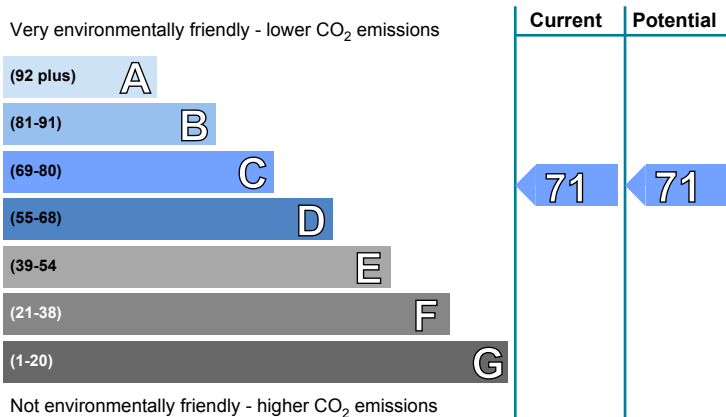
Environmental Impact (CO₂) Rating

This graph shows the effect of your home on the environment in terms of carbon dioxide (CO₂) emissions. The higher the rating, the less impact it has on the environment.
