Home Report

Scottish
Single Survey

Property address	Flat 2/1 8 Portland Street Troon KA10 6EA
Customer	Mr & Mrs P Smyth
Customer address	Flat 2/1 8 Portland Street Troon KA10 6EA
Prepared by	Shepherd Chartered Surveyors
Date of inspection	04/07/2024

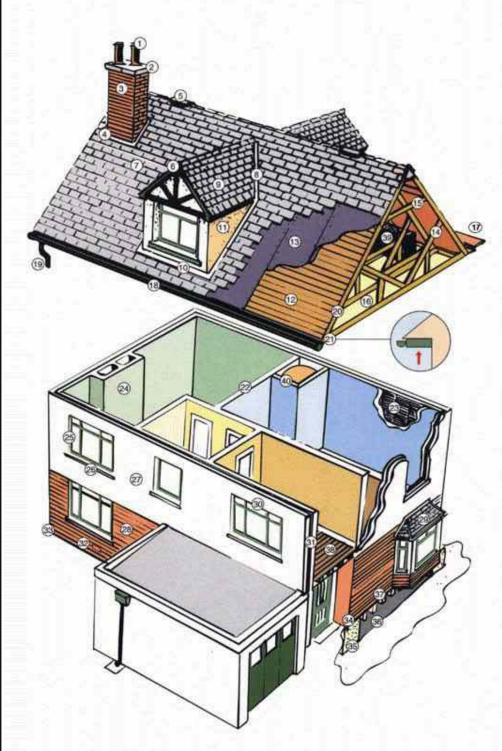
Sectional Diagram showing elements of a typical house

Reference may be made in this report to some or all of the above component parts of the property. This diagram may assist you in locating and understanding these items.

- 1) Chimney pots
- 2) Coping stone
- (3) Chimney head
- (4) Flashing
- 5) Ridge ventilation
- (6) Ridge board
- (7) Slates / tiles
- 8 Valley guttering
- 9 Dormer projection
- 10) Dormer flashing
- 11) Dormer cheeks
- (12) Sarking
- 13) Roof felt
- 14) Trusses
- (15) Collar
- 16) Insulation
- 17) Parapet gutter
- 18) Eaves guttering
- (19) Rainwater downpipe
- 20) Verge boards/skews
- 21) Soffit boards
- 22) Partition wall
- (23) Lath / plaster
- (24) Chimney breast
- 25) Window pointing
- 26) Window sills
- 27) Rendering
- 28) Brickwork / pointing
- 29 Bay window projection
- (30) Lintels
- (31) Cavity walls / wall ties
- 32) Subfloor ventilator
- (33) Damp proof course
- 34) Base course
- 35) Foundations
- 36) Solum
- Floor joists
- 38) Floorboards
- 39) Water tank
- 40) Hot water tank
