# HOME REPORT

9A BENSLEY AVENUE  
GIRDLE TOLL  
IRVINE  
KA11 1AH

# Energy Performance Certificate (EPC)

9A BENSLEY AVENUE, GIRDLE TOLL, IRVINE, KA11 1AH

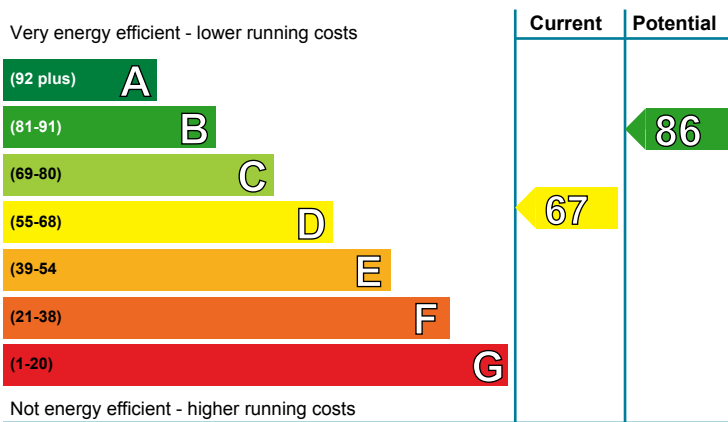
## Energy Efficiency Rating

This graph shows the current efficiency of your home, taking into account both energy efficiency and fuel costs. The higher this rating, the lower your fuel bills are likely to be.

Your current rating is **band D (67)**. The average rating for EPCs in Scotland is **band D (61)**.

The potential rating shows the effect of undertaking all of the improvement measures listed within your recommendations report.
