HOME REPORT

5 OLD PERCETON
IRVINE
KA11 2AE

Energy Performance Certificate (EPC)

5 OLD PERCETON, IRVINE, KA11 2AE

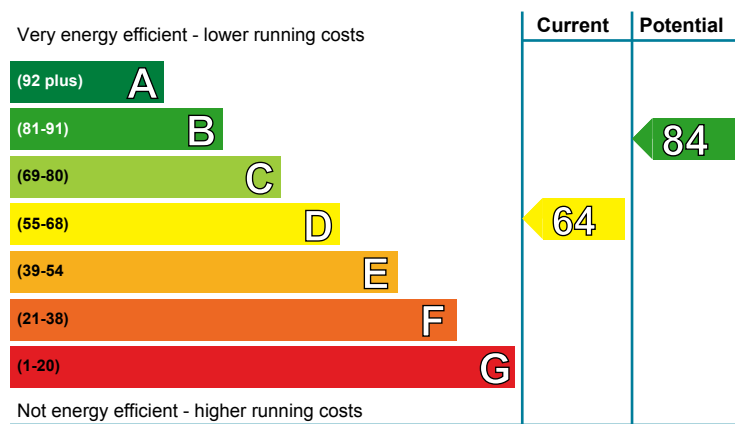
Energy Efficiency Rating

This graph shows the current efficiency of your home, taking into account both energy efficiency and fuel costs. The higher this rating, the lower your fuel bills are likely to be.

Your current rating is **band D (64)**. The average rating for EPCs in Scotland is **band D (61)**.

The potential rating shows the effect of undertaking all of the improvement measures listed within your recommendations report.

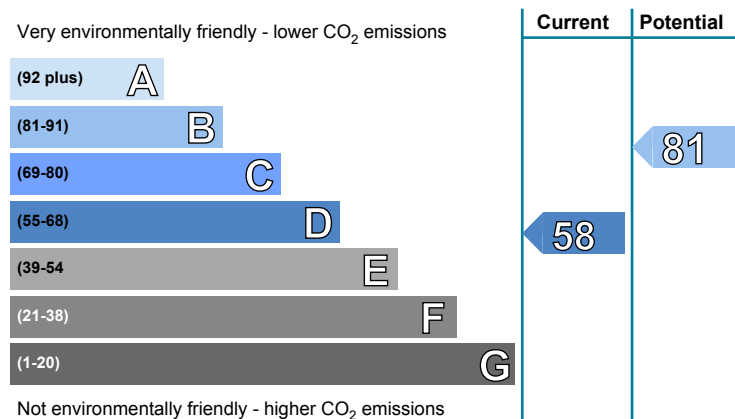
Environmental Impact (CO₂) Rating

This graph shows the effect of your home on the environment in terms of carbon dioxide (CO₂) emissions. The higher the rating, the less impact it has on the environment.

Your current rating is **band D (58)**. The average rating for EPCs in Scotland is **band D (59)**.

The potential rating shows the effect of undertaking all of the improvement measures listed within your recommendations report.
