**HOME**  
report

# Single Survey

<b>Property address</b>	Flat 1/2, 16 Battlefield Avenue, Glasgow, G42 9HP
-------------------------	--

<b>Prepared by</b>	Harvey Donaldson And Gibson
--------------------	-----------------------------

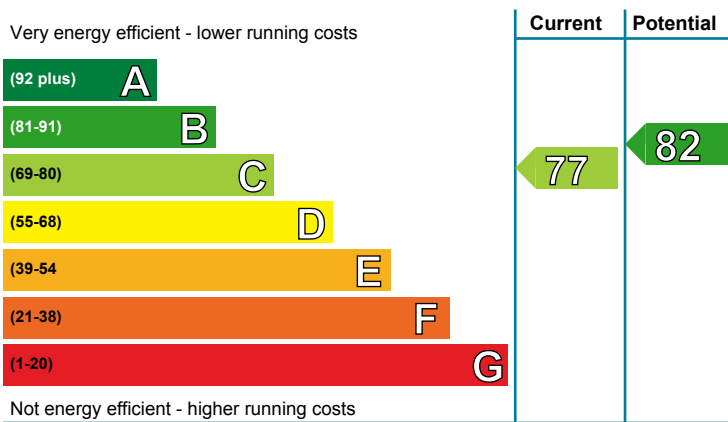
## Energy Efficiency Rating

This graph shows the current efficiency of your home, taking into account both energy efficiency and fuel costs. The higher this rating, the lower your fuel bills are likely to be.

Your current rating is **band C (77)**. The average rating for EPCs in Scotland is **band D (61)**.

The potential rating shows the effect of undertaking all of the improvement measures listed within your recommendations report.

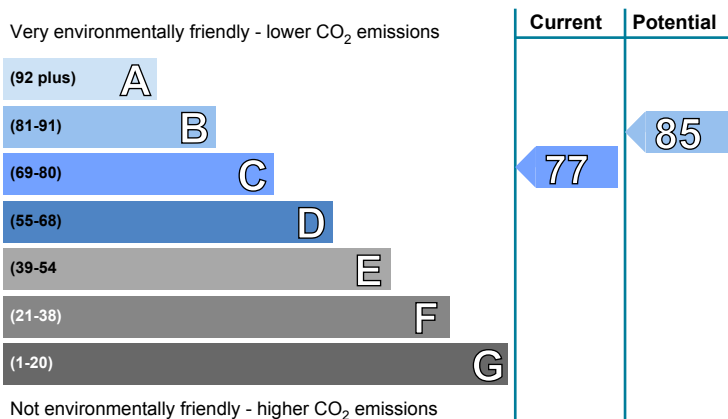
## Environmental Impact (CO<sub>2</sub>) Rating

This graph shows the effect of your home on the environment in terms of carbon dioxide (CO<sub>2</sub>) emissions. The higher the rating, the less impact it has on the environment.
