SINGLE SURVEY  
ENERGY REPORT  
PROPERTY QUESTIONNAIRE  
VALUATION REPORT

## Survey report on:

<b>Property Address</b>	8a East Netherton Street Kilmarnock KA1 4AX
<b>Customer</b>	Mr Murdoch & Mrs Murdoch
<b>Date of Inspection</b>	15/05/2024
<b>Prepared by</b>	Ross Macaulay Harvey Donaldson & Gibson Chartered Surveyors

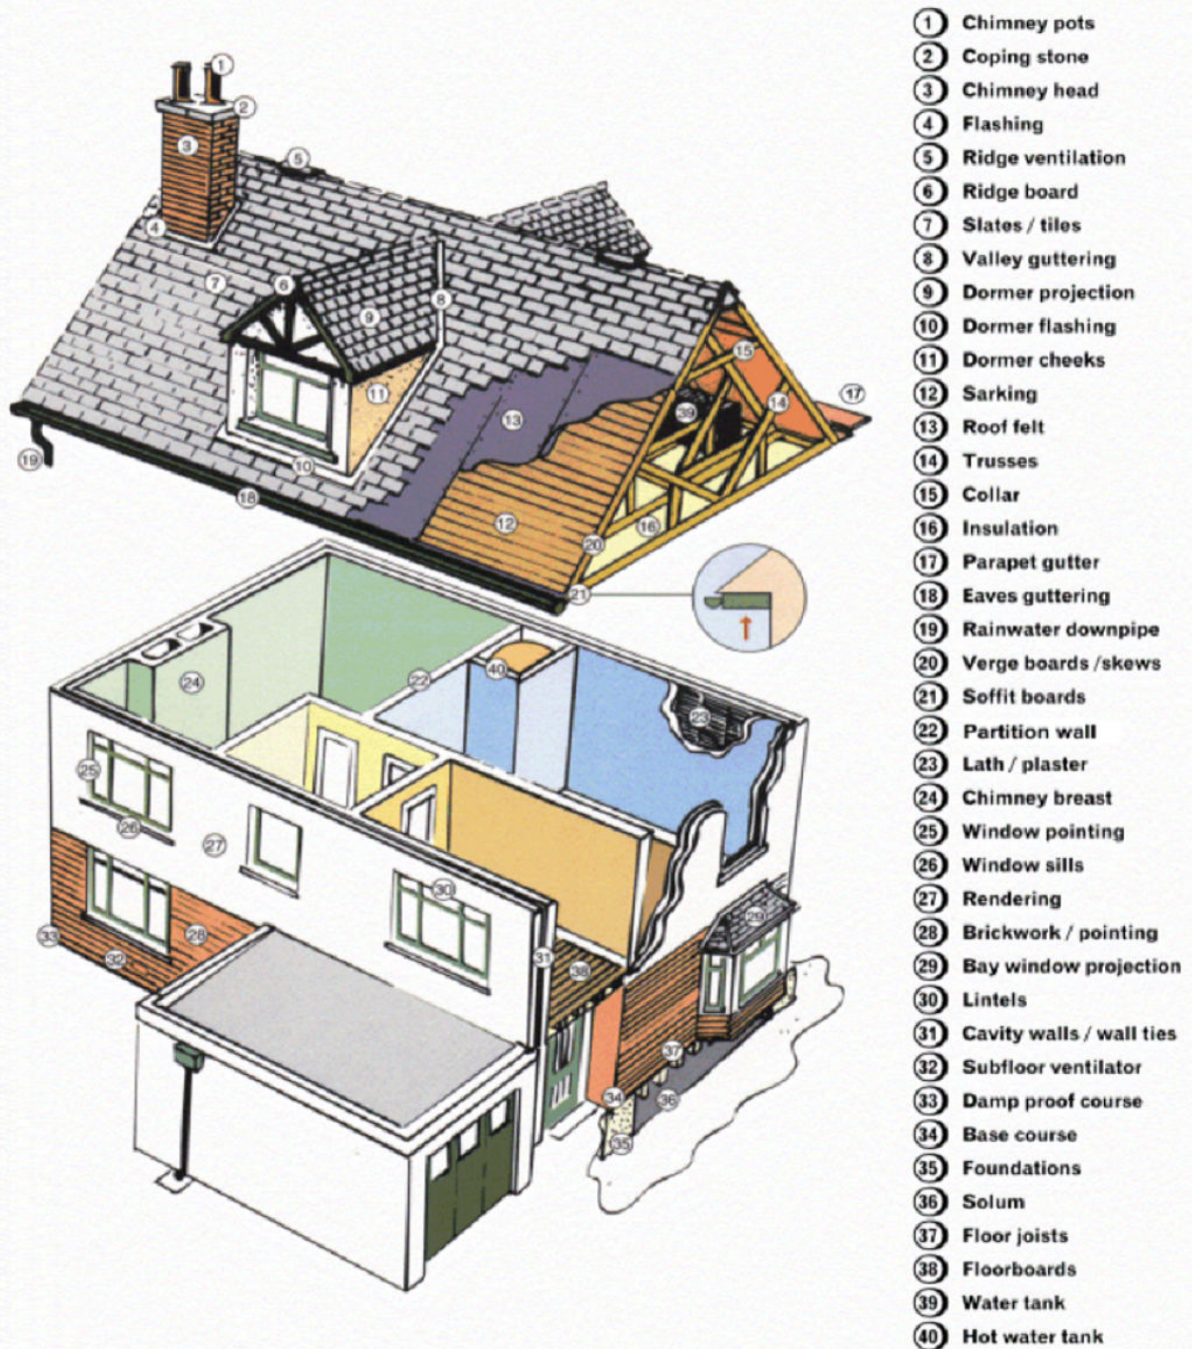
## Sectional Diagram showing elements of a typical house

Reference may be made in this report to some or all of the above component parts of the property. This diagram may assist you in locating and understanding these items.
