Home Report

Single Survey

| Property address | 38 Kay Park Crescent Kilmarnock KA3 7BA |

| Prepared by | Shepherd Chartered Surveyors |

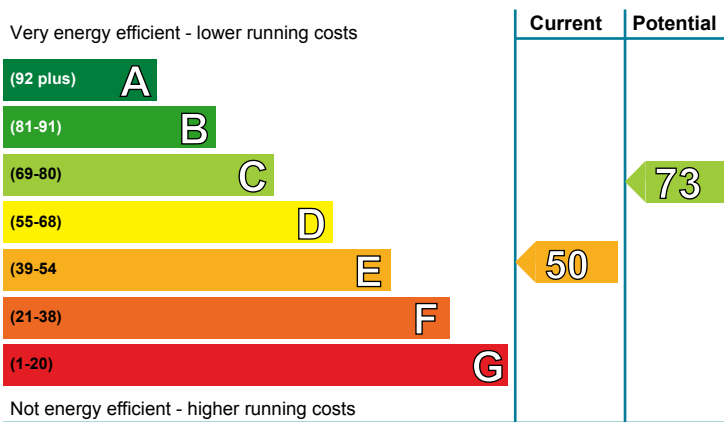
Energy Efficiency Rating

This graph shows the current efficiency of your home, taking into account both energy efficiency and fuel costs. The higher this rating, the lower your fuel bills are likely to be.

Your current rating is **band E (50)**. The average rating for EPCs in Scotland is **band D (61)**.

The potential rating shows the effect of undertaking all of the improvement measures listed within your recommendations report.

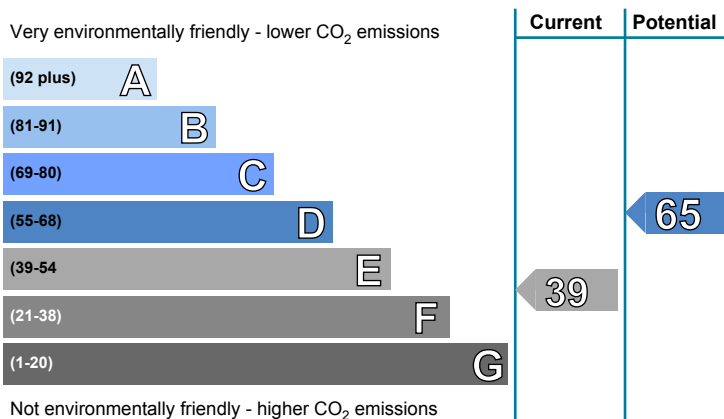
Environmental Impact (CO₂) Rating

This graph shows the effect of your home on the environment in terms of carbon dioxide (CO₂) emissions. The higher the rating, the less impact it has on the environment.
