Home Report

Single Survey

Property address	10 Annandale Crescent Crosshouse Kilmarnock KA2 0EP
Customer	Carol Ann Burley
Customer address	10 Annandale Crescent Crosshouse Kilmarnock KA2 0EP
Prepared by	Shepherd Chartered Surveyors
Date of inspection	28/10/2024

Energy Performance Certificate (EPC)

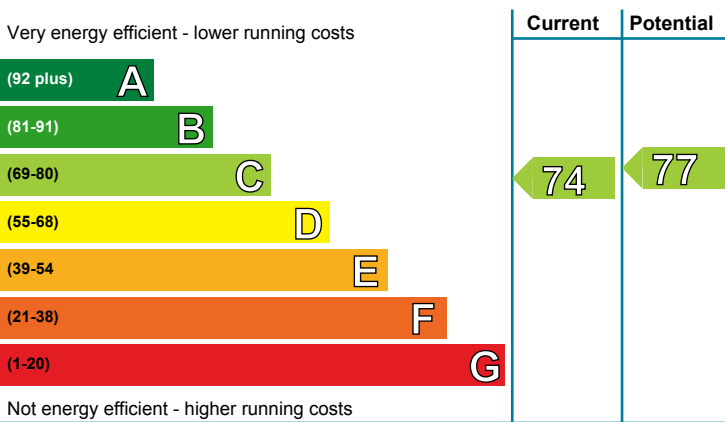
Energy Efficiency Rating

This graph shows the current efficiency of your home, taking into account both energy efficiency and fuel costs. The higher this rating, the lower your fuel bills are likely to be.

Your current rating is **band C (74)**. The average rating for EPCs in Scotland is **band D (61)**.

The potential rating shows the effect of undertaking all of the improvement measures listed within your recommendations report.

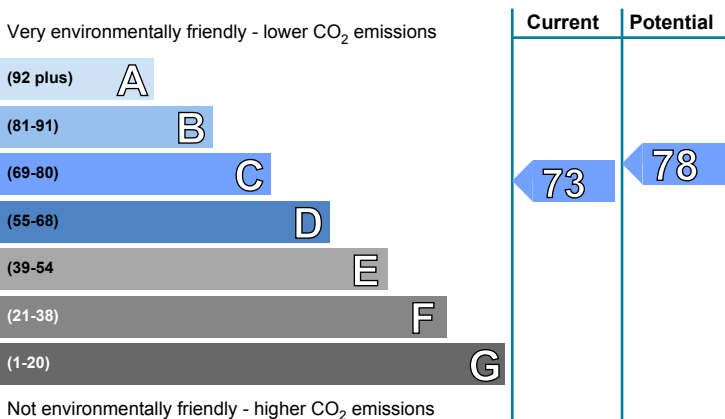
Environmental Impact (CO₂) Rating

This graph shows the effect of your home on the environment in terms of carbon dioxide (CO₂) emissions. The higher the rating, the less impact it has on the environment.
