HOME REPORT

28 BRAEHEAD GIRDLE TOLL IRVINE KA11 1BD

Energy Performance Certificate (EPC)

survey report on:

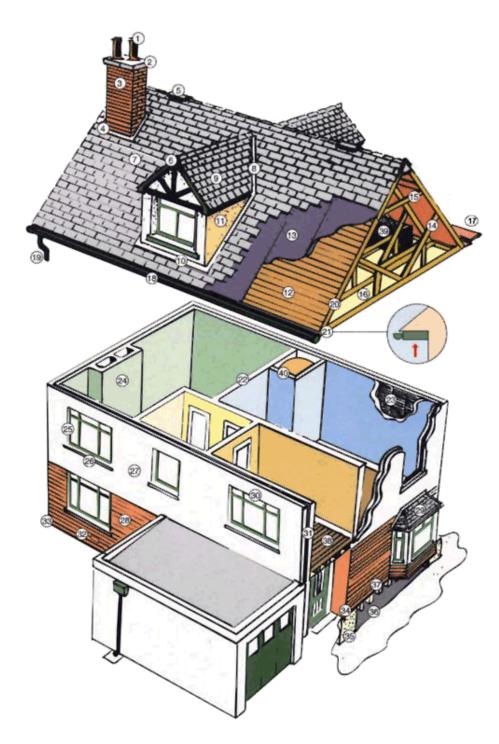
Sectional Diagram showing elements of a typical house

Reference may be made in this report to some or all of the above component parts of the property. This diagram may assist you in locating and understanding these items.

- 1) Chimney pots
- 2) Coping stone
- 3) Chimney head
- 4 Flashing
- 5 Ridge ventilation
- 6) Ridge board
- 7) Slates / tiles
- 8 Valley guttering
- 9 Dormer projection
- 10) Dormer flashing
- 11) Dormer cheeks
- (12) Sarking
- 13) Roof felt
- (14) Trusses
- (15) Collar
- 16 Insulation
- 17) Parapet gutter
- (18) Eaves guttering
- 19) Rainwater downpipe
- 20) Verge boards/skews
- 21) Soffit boards
- 22) Partition wall
- 23) Lath / plaster
- 24) Chimney breast
- (25) Window pointing
- 26) Window sills
- 27) Rendering
- (28) Brickwork / pointing
- 29) Bay window projection
- 30 Lintels
- (31) Cavity walls / wall ties
- 32) Subfloor ventilator
- 33) Damp proof course
- 34) Base course
- 35) Foundations
- (36) Solum
- 37) Floor joists
- 38) Floorboards
- 39) Water tank
- 40 Hot water tank
