HOME REPORT

6 KERR DRIVE
IRVINE
KA12 0JH

ENERGY PERFORMANCE CERTIFICATE

SINGLE SURVEY

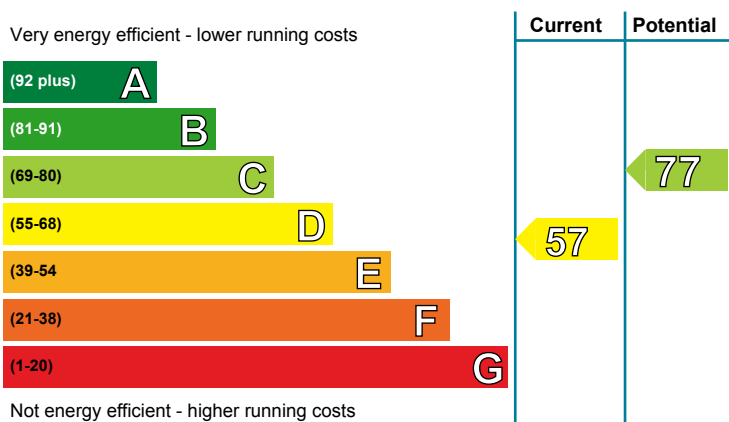
Energy Efficiency Rating

This graph shows the current efficiency of your home, taking into account both energy efficiency and fuel costs. The higher this rating, the lower your fuel bills are likely to be.

Your current rating is **band D (57)**. The average rating for EPCs in Scotland is **band D (61)**.

The potential rating shows the effect of undertaking all of the improvement measures listed within your recommendations report.

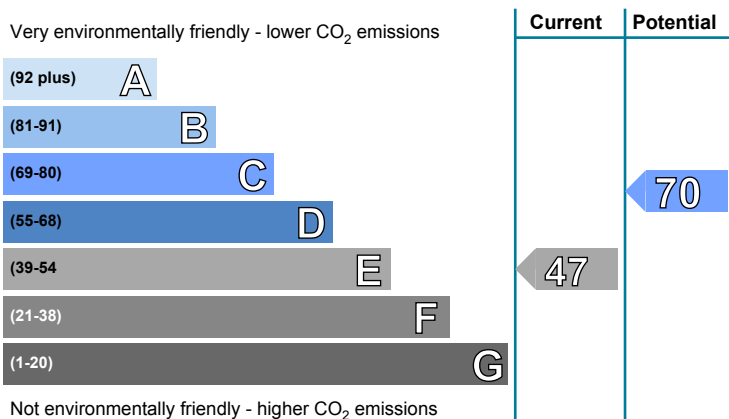
Environmental Impact (CO₂) Rating

This graph shows the effect of your home on the environment in terms of carbon dioxide (CO₂) emissions. The higher the rating, the less impact it has on the environment.

Your current rating is **band E (47)**. The average rating for EPCs in Scotland is **band D (59)**.

The potential rating shows the effect of undertaking all of the improvement measures listed within your recommendations report.
