YOUR ONESURVEY HOME REPORT

36 Meadow Way Kilwinning KA13 6UX

Single Survey

Prepared by	Steven Kennedy, BSc (Hons) MRICS
	D M Hall - Irvine

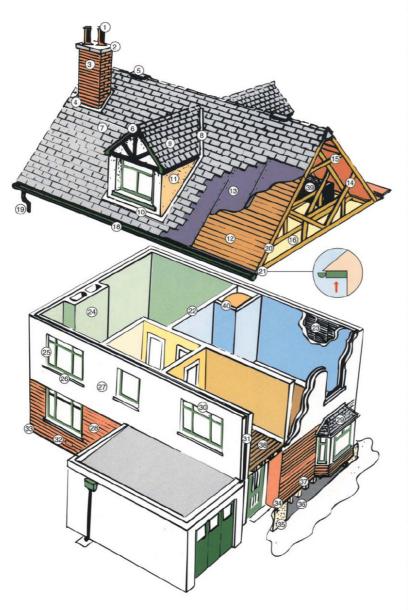
Sectional Diagram showing elements of a typical house

Reference may be made in this report to some or all of the above component parts of the property. This diagram may assist you in locating and understanding these items.

1 Chimney pots Coping stone 2 Chimney head 3 Flashing 4 (5) **Ridge ventilation** 6 Ridge board 7 Slates / tiles 8 Valley guttering 9 Dormer projection (10) Dormer flashing **Dormer cheeks** (12) Sarking (13) Roof felt (14) Trusses (15) Collar 16 Insulation (17) Parapet gutter (18) Eaves guttering (19) Rainwater downpipe (20) Verge boards / skews (21) Soffit boards 2 Partiton wall (23) Lath / plaster (24) Chimney breast (25) Window pointing (26) Window sills (27) Rendering (28) Brickwork / pointing (29) Bay window projection 30 Lintels (31) Cavity walls / wall ties 32 Subfloor ventilator (33) Damp proof course (34) Base course (35) Foundations (36) Solum
