HOME REPORT

3 BEECH AVENUE
IRVINE
KA12 0JB

Energy Performance Certificate (EPC)

Single Survey

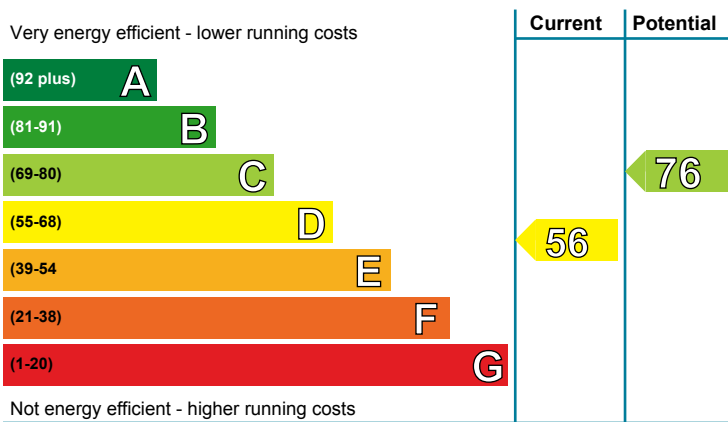
Energy Efficiency Rating

This graph shows the current efficiency of your home, taking into account both energy efficiency and fuel costs. The higher this rating, the lower your fuel bills are likely to be.

Your current rating is **band D (56)**. The average rating for EPCs in Scotland is **band D (61)**.

The potential rating shows the effect of undertaking all of the improvement measures listed within your recommendations report.
