# Home Report

# Scottish Single Survey

<b>Property address</b>	20 Loudoun Street Stewarton Kilmarnock KA3 5JD
<b>Customer</b>	Sandra Fleming
<b>Customer address</b>	20 Loudoun Street Stewarton Kilmarnock KA3 5JD
<b>Prepared by</b>	Shepherd Chartered Surveyors
<b>Date of inspection</b>	19/03/2025

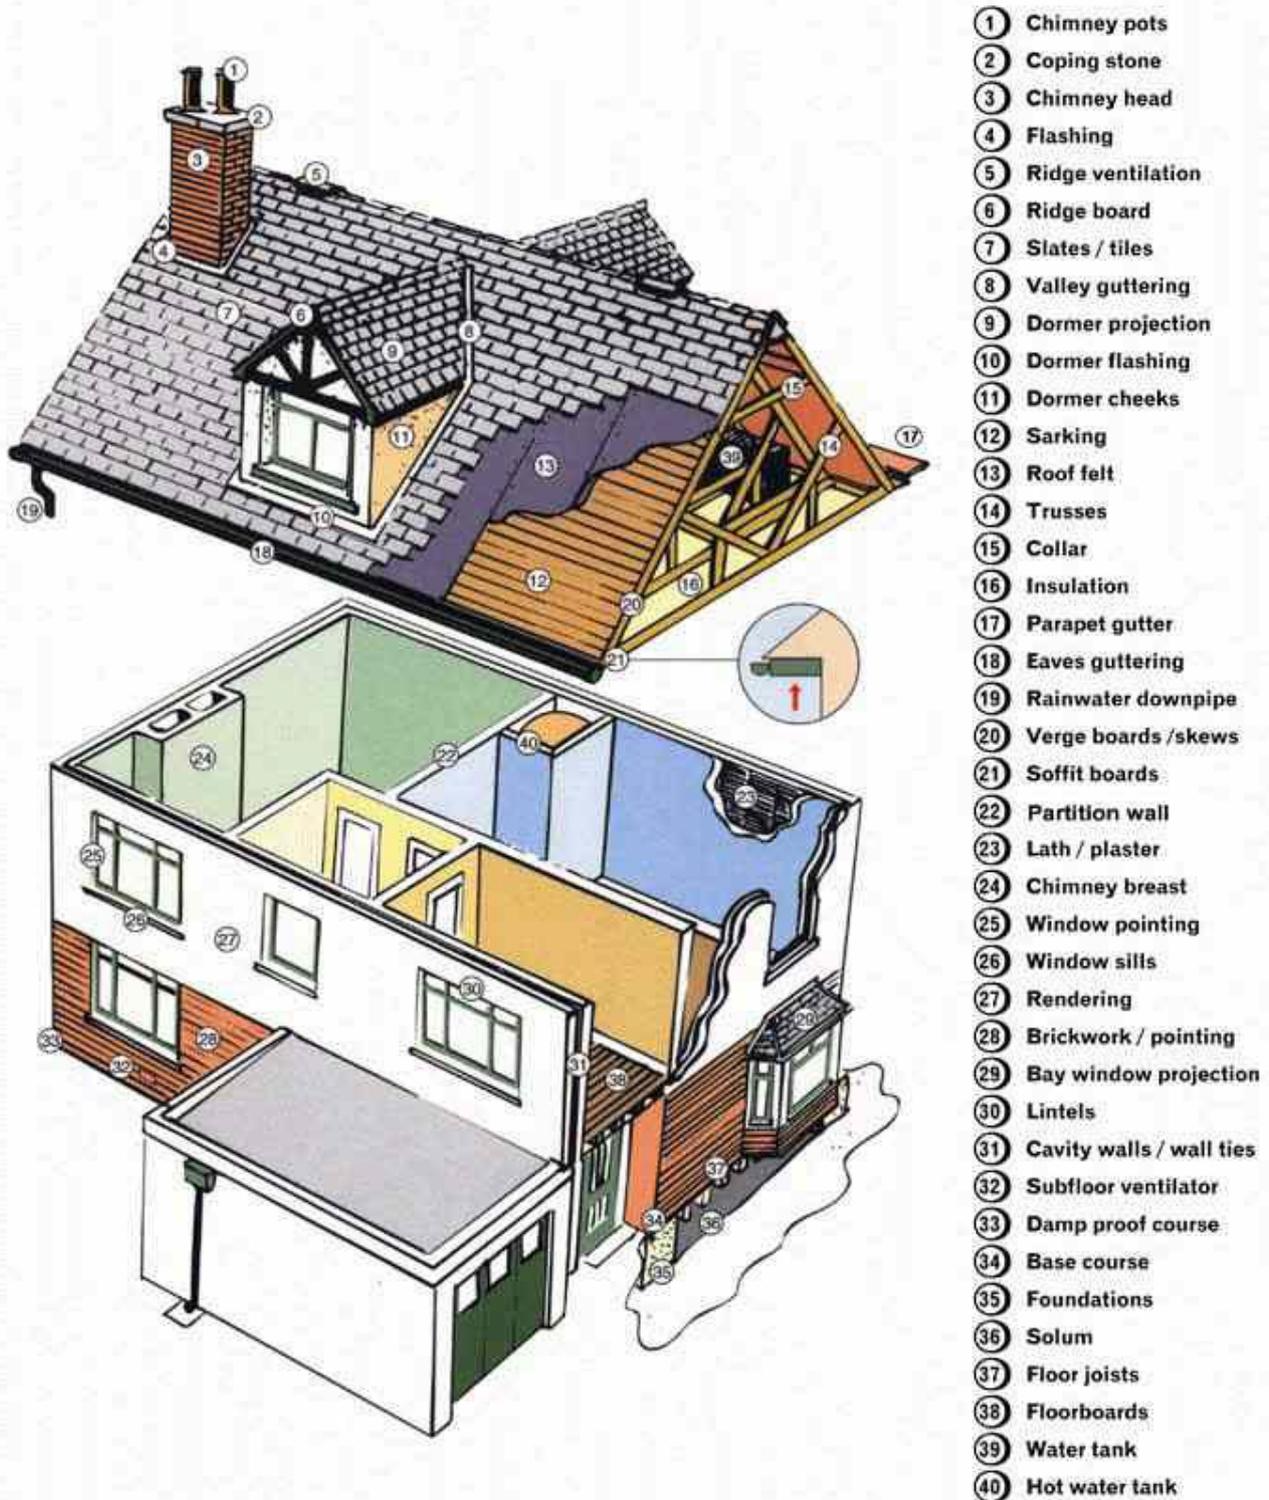
## Sectional Diagram showing elements of a typical house

Reference may be made in this report to some or all of the above component parts of the property. This diagram may assist you in locating and understanding these items.
